NASA/TM-2016-218978

Ultrasonic Nondestructive Evaluation of Pultruded Rod Stitched Efficient Unitized Structure (PRSEUS) During Large-Scale Load Testing and Rod Push-Out Testing

*Patrick H. Johnston and Peter D. Juarez
Langley Research Center, Hampton, Virginia 23681*

May 2016

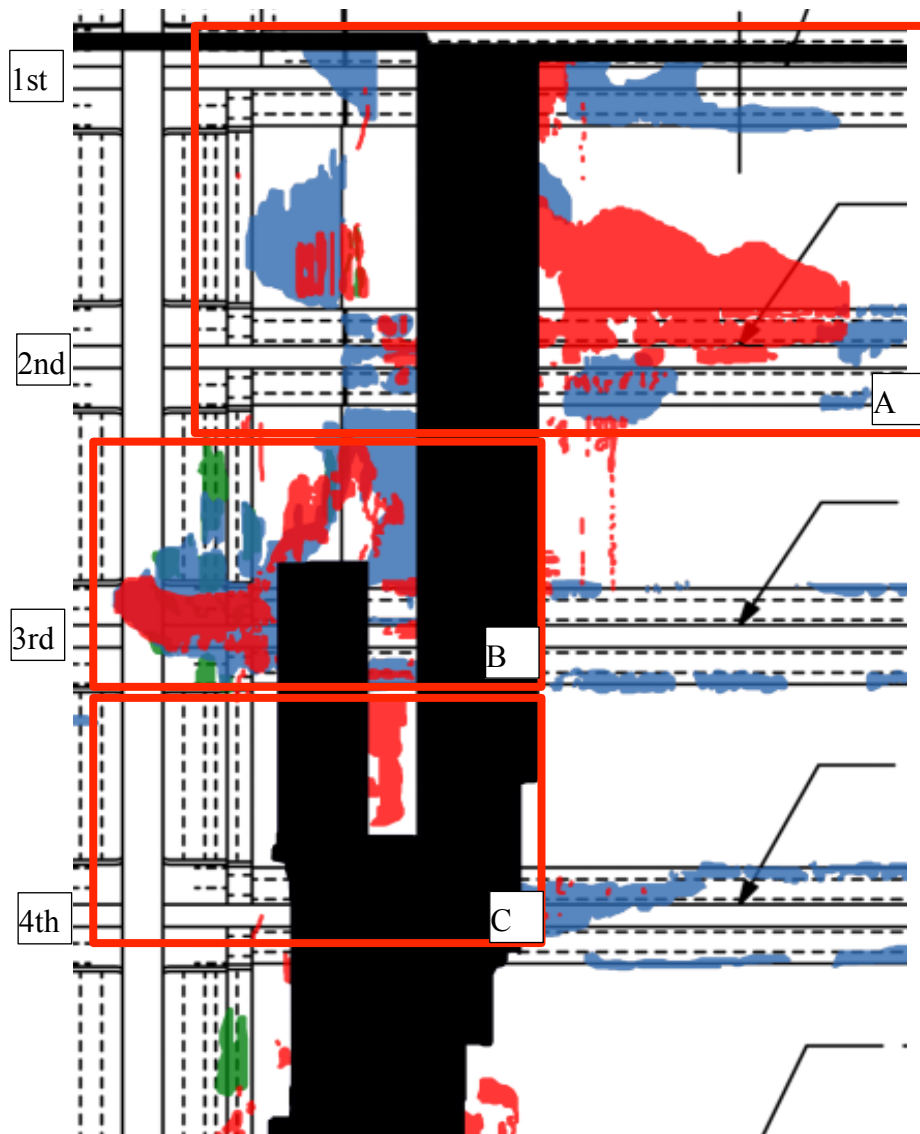
FIGURE 39. Detailed image of the upper portion of the forward bulkhead failure crack scans

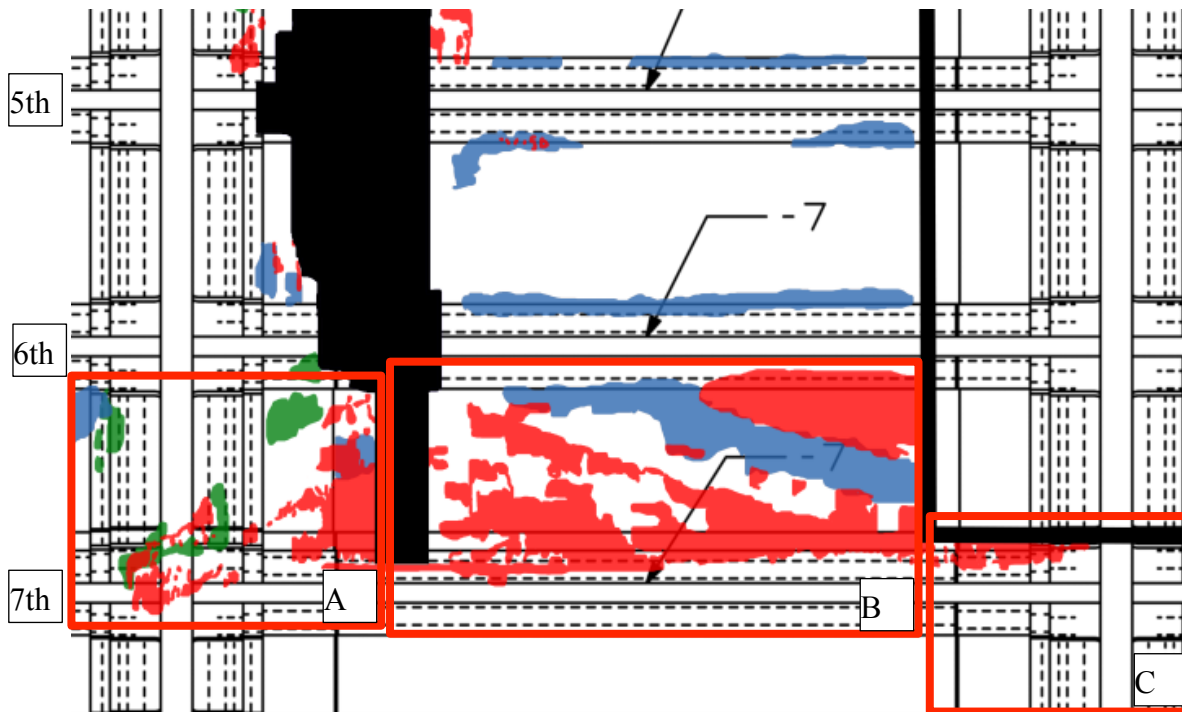
FIGURE 41. Detailed image lower section of the forward bulkhead failure crack scans.

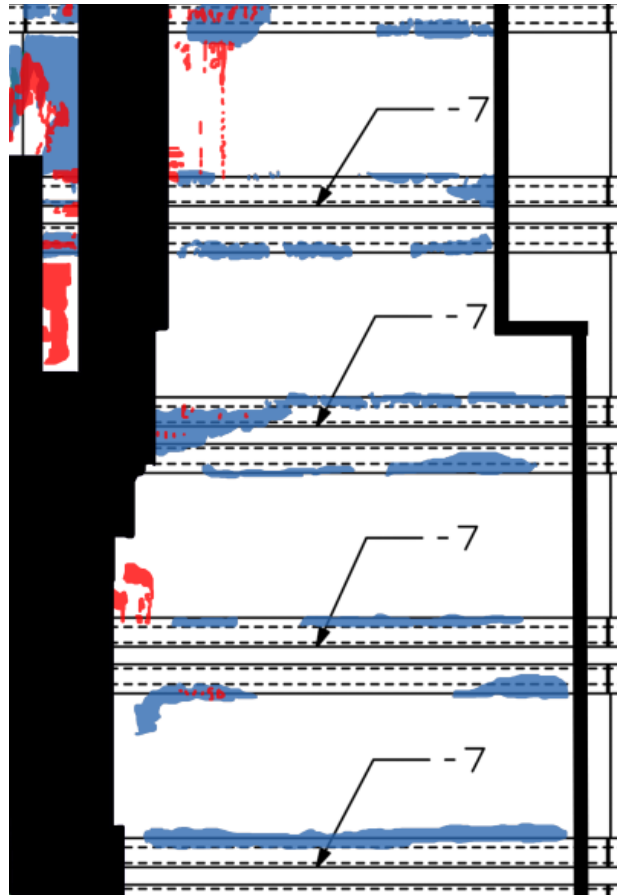
FIGURE 42. Detailed image showing the delaminations that have occurred in the first stitch line stringer/skin interface.

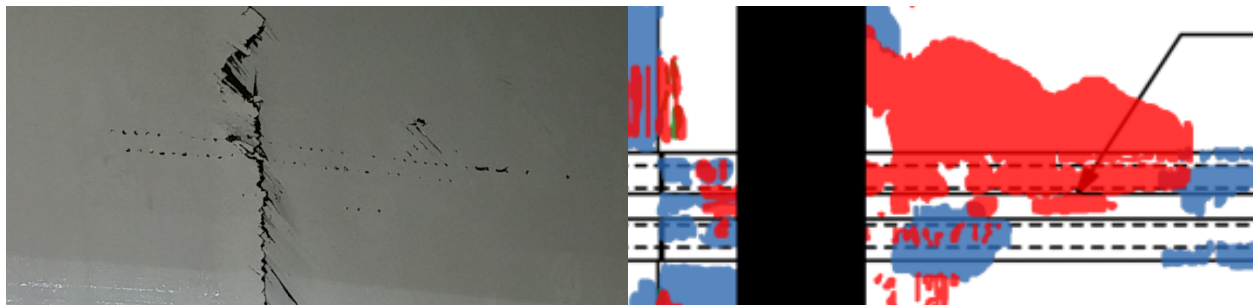
FIGURE 43. Photo of the surface damage caused by failed stitches rebounding against the surface, and the corresponding ultrasonic data.

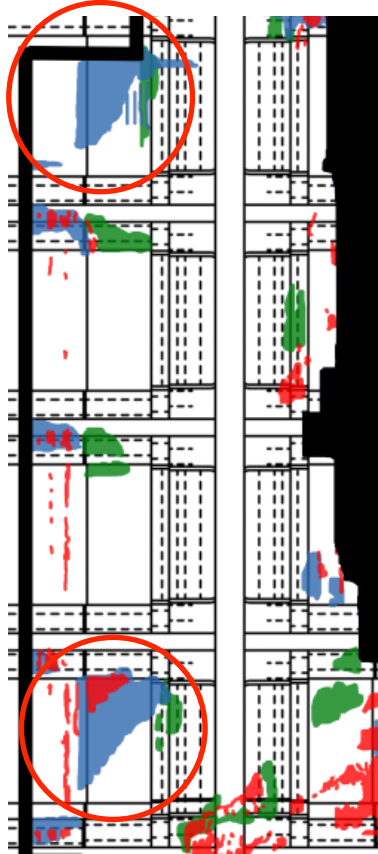
FIGURE 44. Image of anomalous delamination patterns on the opposite side of the vertical frame, shown inside the red circles.

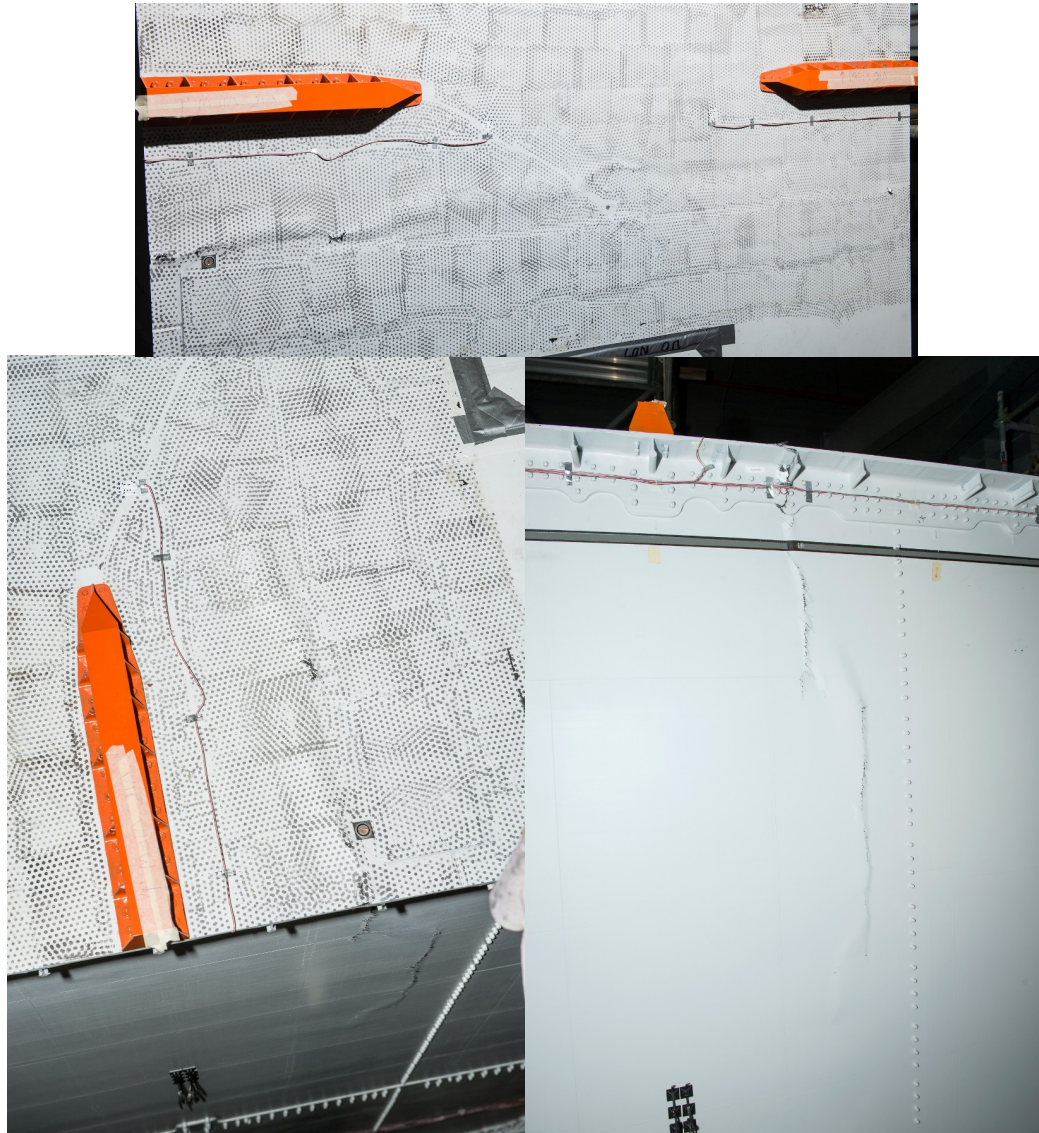
FIGURE 45. Photos showing the connection between the starboard side failure crack on the crown and the crack on the aft bulkhead.

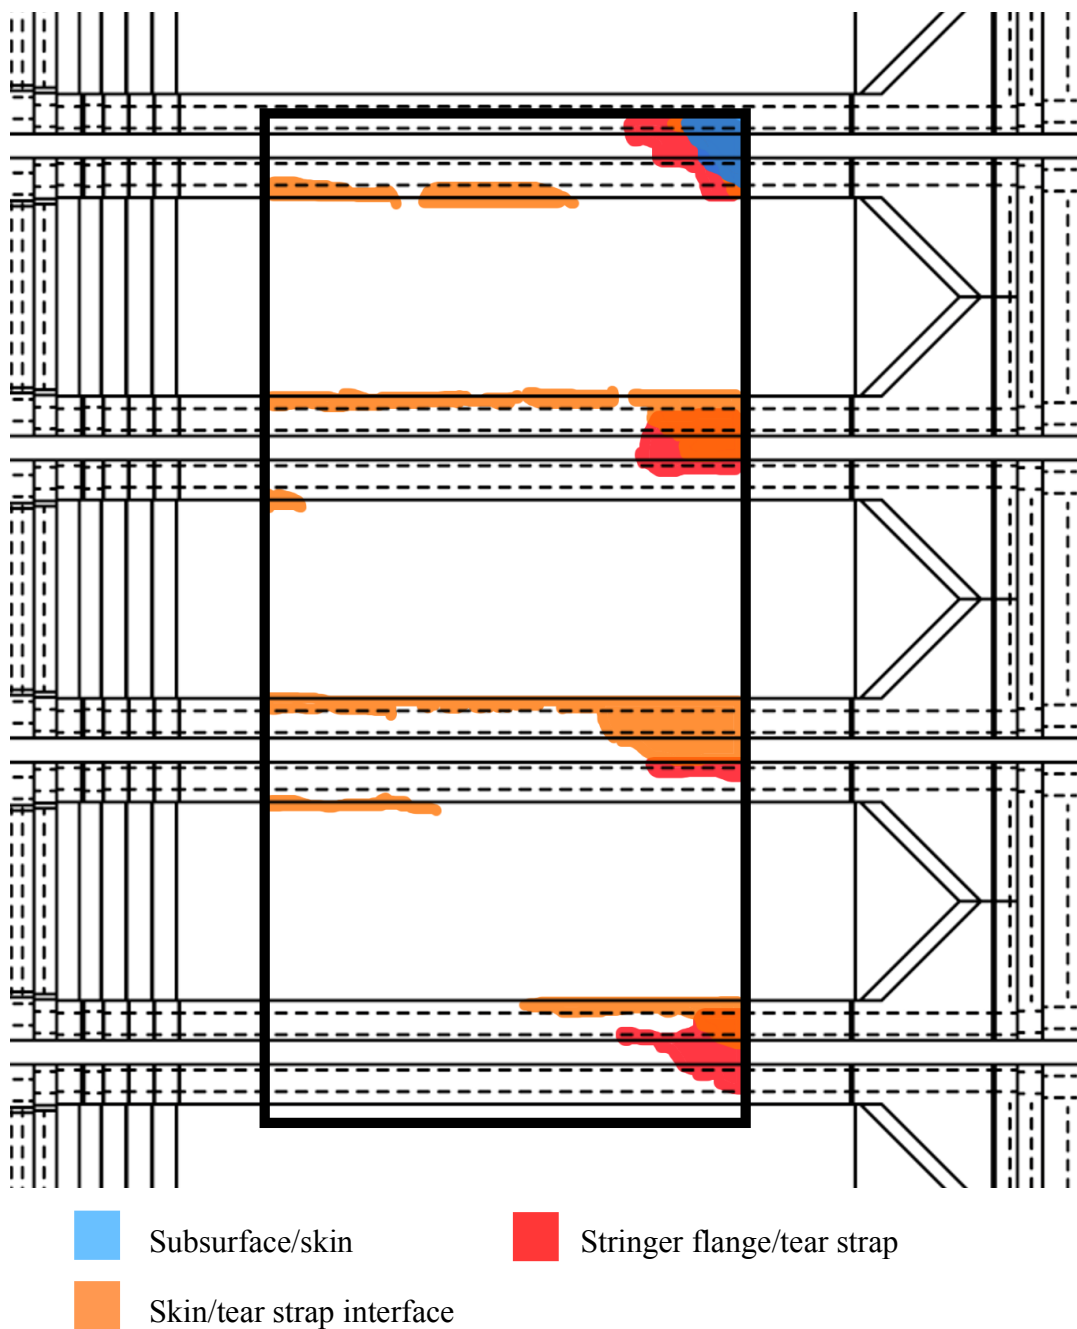
FIGURE 47. Damage map of a scanned section of the aft bulkhead. This section was located on the port side of the failure crack.

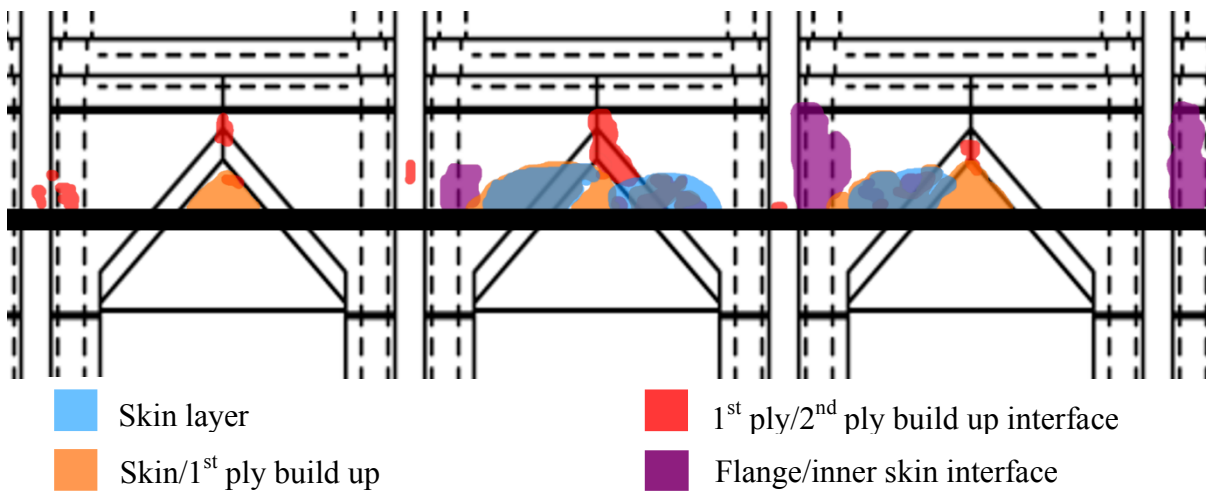
FIGURE 49. Damage map of the second scan area of the aft bulkhead.

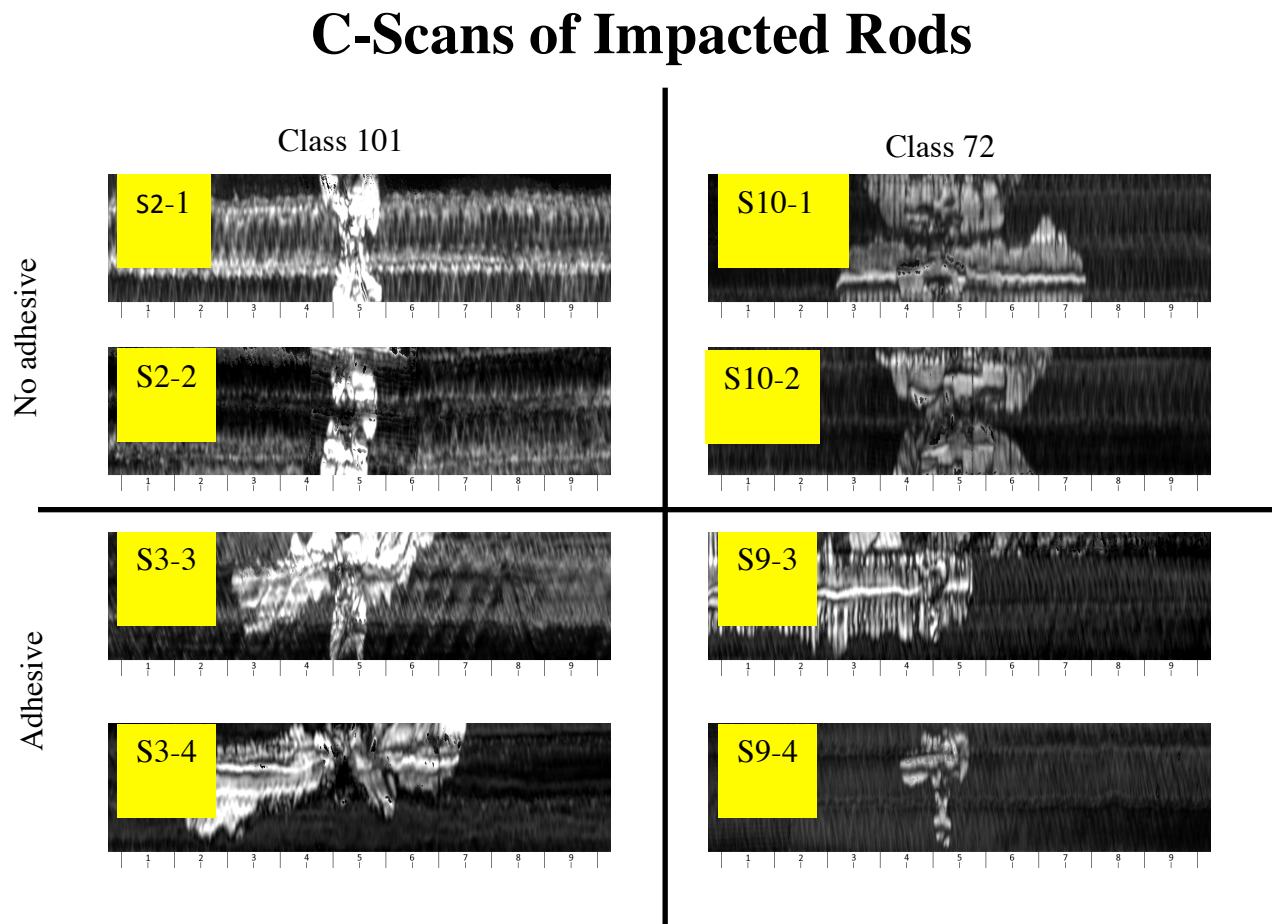
Eight rod specimens were subject to impact at the midpoint of the 9-inch length. These were rescanned ultrasonically to measure the extent of impact damage. C-scan images of these specimens are presented in Fig. 50.

FIGURE 50. C-scans of impacted rod segments before cutting into push-out specimens.
